**EVALUATION OF DSH/JP-8 FUEL BLENDS:  
REGARDING ITS EFFECTIVENESS FOR USE IN  
GROUND VEHICLES AND EQUIPMENT**

**INTERIM REPORT  
TFLRF No. 482**

**U.S. Army TARDEC Fuels and Lubricants Research Facility  
Southwest Research Institute® (SwRI®)  
San Antonio, TX**

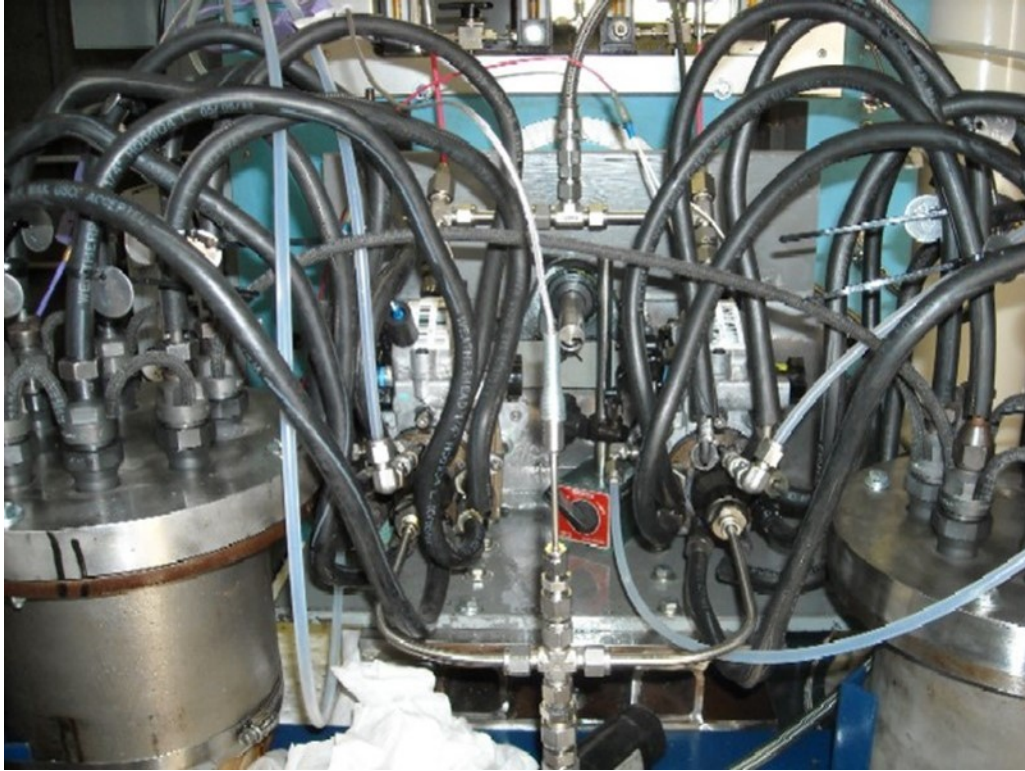
The high-pressure outlets from the pumps were connected to eight Bosch Model O432217276 fuel injectors for a 6.5LT turbocharged engine and assembled in a collection canister. Fuel from both canisters was then returned to the 55-gallon drum. A separate line was used to return excess fuel from the governor housing to the fuel supply. Fuel-to-water heat exchangers on both the return lines from the injector canisters and the governor housing were used to cool the fuel. The test stand with pumps mounted is shown in Figure 3.

**Figure 3. Dual Stanadyne Rotary Fuel Injection Pumps Mounted on Stand with Fuel Injectors**

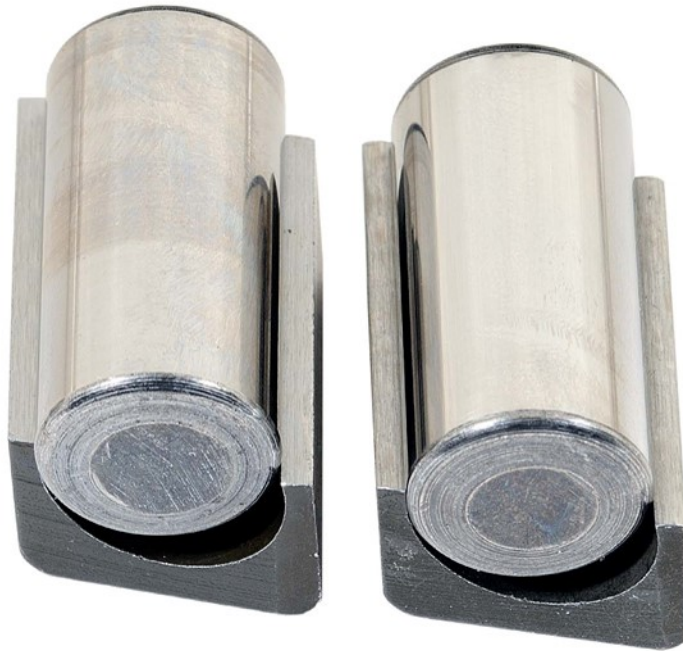
**Figure 11. Pump SN:17102937 Rollers and Shoe before Testing with 20/80 DSH8/JP-8 Fuel with 9-ppm CI/LI**

Figure 11 and Figure 12 is the Pre-Test and Post-Test conditions of the fuel injection pump SN:17102937 roller shoe and roller conditions. Of note is the lack of a wear scar at the roller shoe leaf spring contact and the shiny, bright rollers shown in Figure 11. Figure 12 reveals mild wear scars on the roller shoe from the leaf spring contact and heavy burnishing of the rollers. The rollers tend to discolor when combination rolling-sliding action occurs as the rollers follow the injection cam profile. The roller shoe and pumping plunger contacts are shown in Figure 13 and Figure 14 that show a relatively mild wear scar on one roller shoe, and moderate wear on the other shoe due to 500-Hours operation. The injection pump cam ring shown in Figure 15 and Figure 16 reveals polishing, scratching, and light scuffing wear on the cam lobes with the 20/80 DSH8/JP-8 Fuel with 9-ppm CI/LI blend.

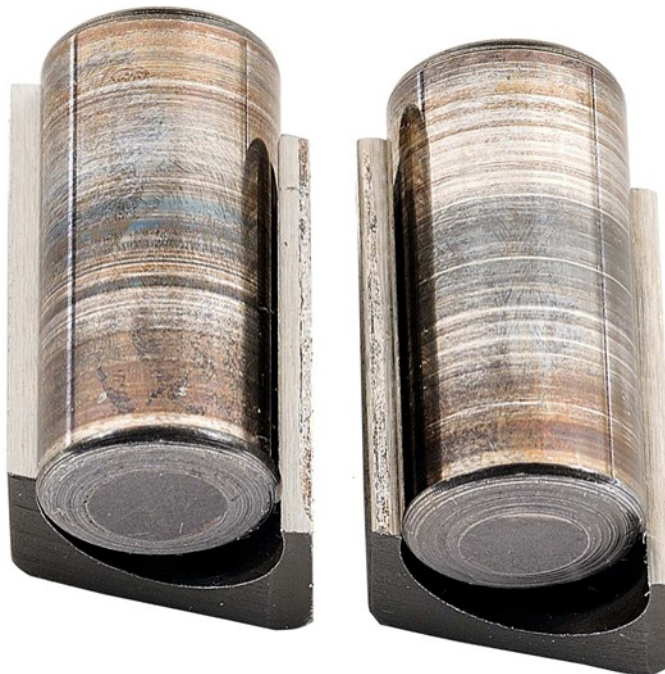
**Figure 12. Pump SN:17102937 Rollers and Shoe with 500-Hours Testing with 20/80 DSH8/JP-8 Fuel with 9-ppm CI/LI**

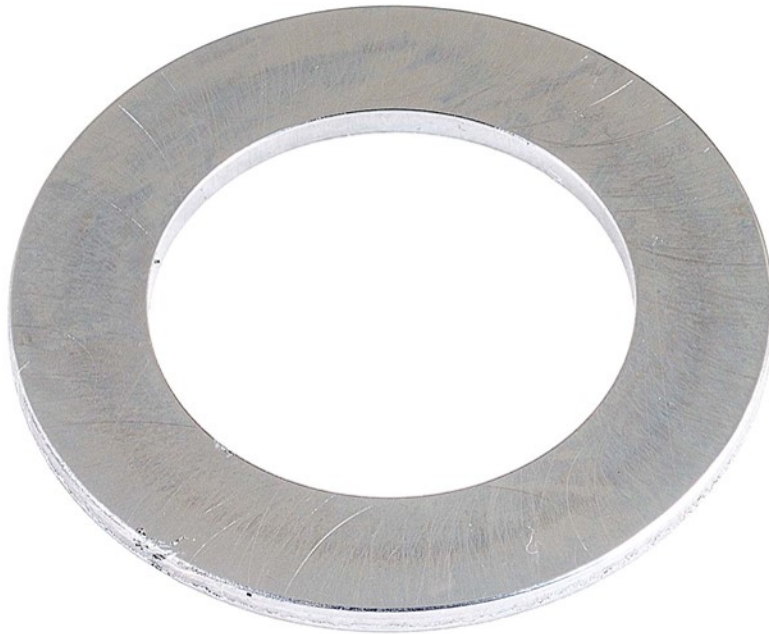
**Figure 17. Pump SN:17102937 Thrust Washer before Testing with 20/80 DSH8/JP-8 Fuel with 9-ppm CI/LI**

The governor thrust washer condition before and after 500-Hours is seen in Figure 17 and Figure 18. The polishing wear seen on the thrust washer in Figure 18 is typical for the 500-hour operating interval. Polishing and fuel deposition wear seen on the advance piston, suggesting there were fuel pressure fluctuations in that area of the fuel injection pump housing. The metering valve regulates

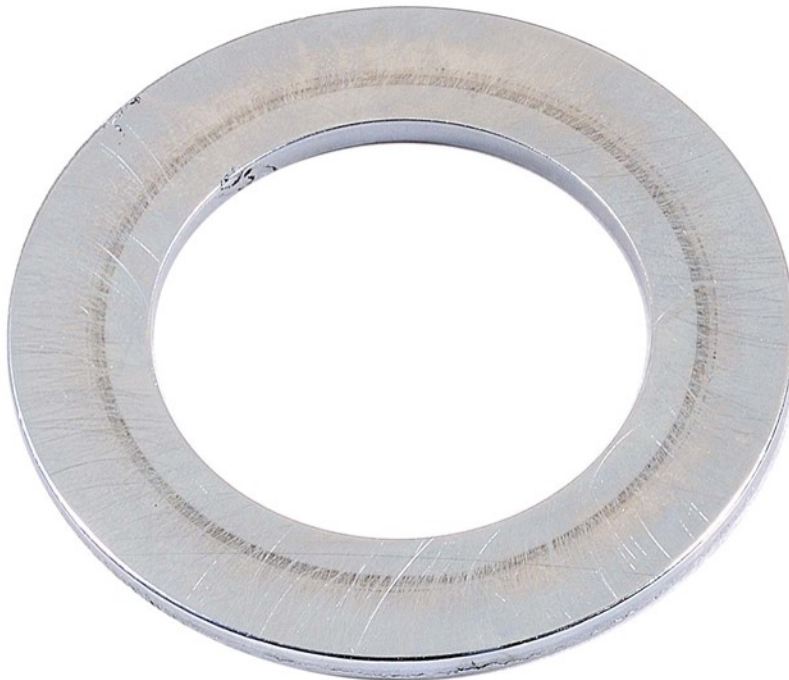
**Figure 18. Pump SN:17102937 Thrust Washer with 500-Hours Testing with 20/80 DSH8/JP-8 Fuel with 9-ppm CI/LI**

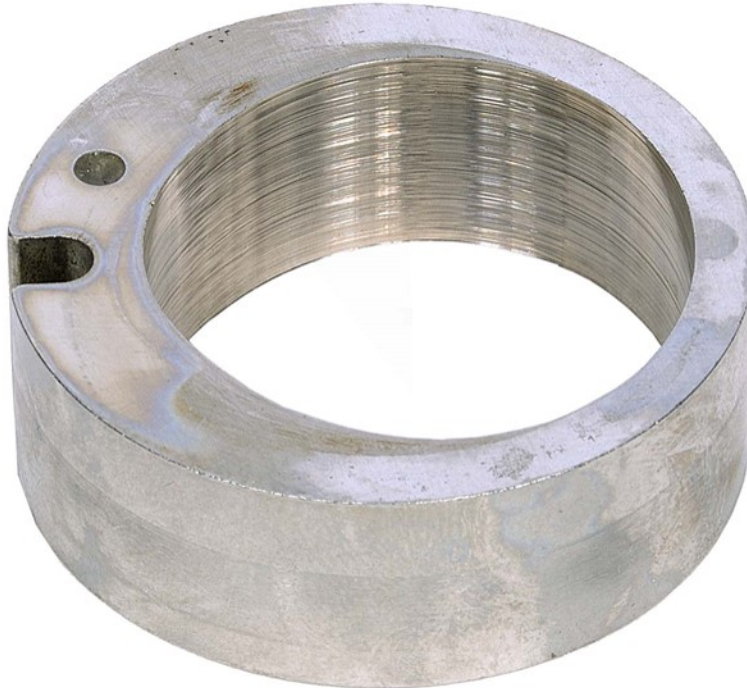
**Figure 19. Pump SN:17102937 Transfer Pump Liner before Testing with 20/80 DSH8/JP-8 Fuel with 9-ppm CI/LI**

**Figure 20. Pump SN:17102937 Transfer Pump Liner with 500-Hours Testing with 20/80 DSH8/JP-8 Fuel with 9-ppm CI/LI**

- For elevated fuel inlet temperature operation, even with petroleum JP-8 at 77 °C, the maximum effective CI/LI concentration is required to provide adequate wear protection.
- For elevated fuel inlet temperature operation, with 20/80 DSH8/JP-8 at 77 °C, the minimum effective CI/LI concentration proved to be borderline effective for the 500-Hours of testing.
- A 20/80 blend of DSH8/JP-8 with 9-ppm CI/LI operated at 77 °C fuel inlet temperature will allow 500-Hours of rotary pump operation. However the performance degradation of the fuel injection pumps at 500-Hours could impact engine governor operation, and component inspections suggested excessive transfer pump liner wear.

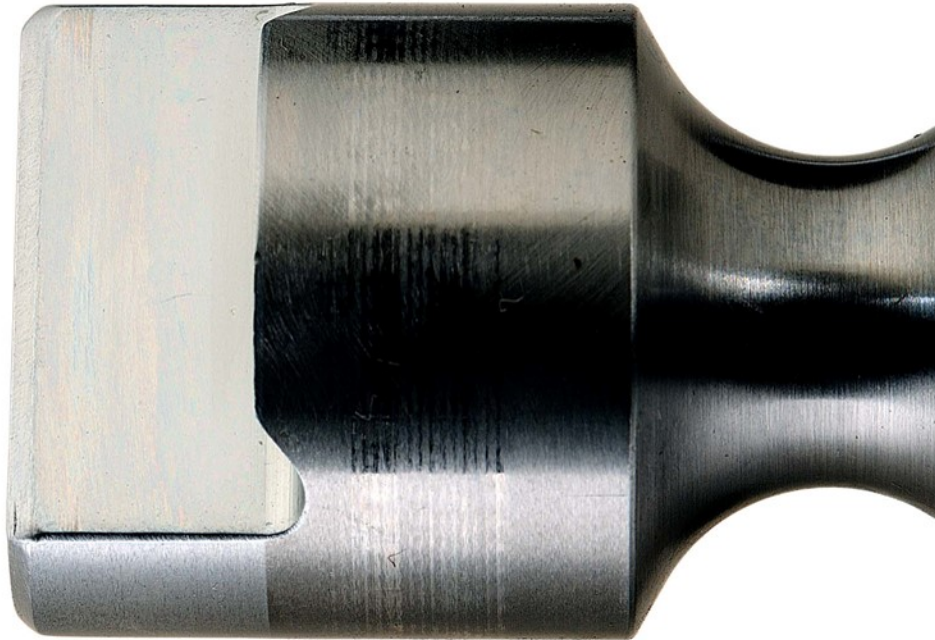
**Figure 25. Pump SN:17102937 Driveshaft Drive Tang Sides before Testing with 20/80 DSH8/JP-8 Fuel with 9-ppm CI/LI**

Figure 25 and Figure 26 show the condition of the injection pump drive shaft drive tang that transmits torque to the hydraulic section of the pump from the engine. Figure 26 reveals a minor wear scar that indicates backlash and timing were not altered with the 20/80 DSH8/JP-8 Fuel with 9-ppm CI/LI blend after 500-Hours at elevated 77 °C fuel inlet temperature.

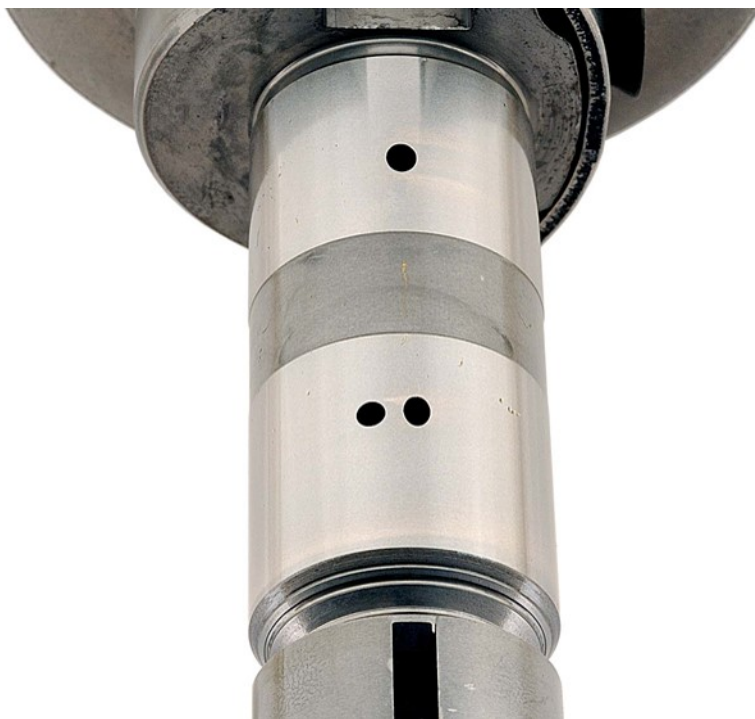
**Figure 27. Pump SN:17102938 Distributor Rotor before Testing with 20/80 DSH8/JP-8 Fuel with 9-ppm CI/LI**

The parts conditions and subjective wear ratings for fuel injection pump SN:17102938 are summarized in Table 12. Images of the wear seen on the components of fuel injection pump SN:17102938 are shown in Figure 27 through Figure 44. Figure 27 and Figure 28 show the condition of the injection pump rotor that carries the plungers and distributes the compressed fuel. Figure 28 shows the discharge ports and rotor with light circumferential scratches and wear near the rotor discharge ports, from wear debris, after the 500-Hours of operation. There also appears to be a small chip missing from the edge of the lower right port..

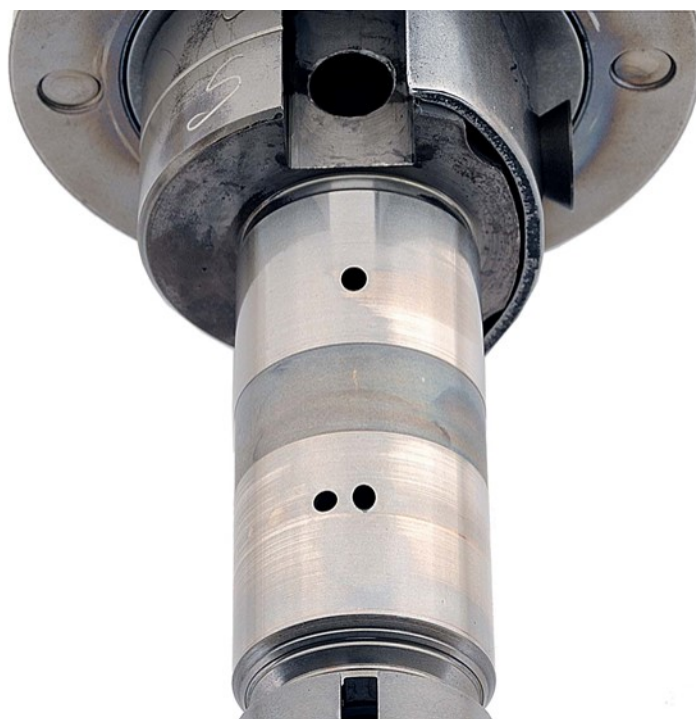
**Figure 28. Pump SN:17102938 Distributor Rotor with 500-Hours Testing with 20/80 DSH8/JP-8 Fuel with 9-ppm CI/LI**

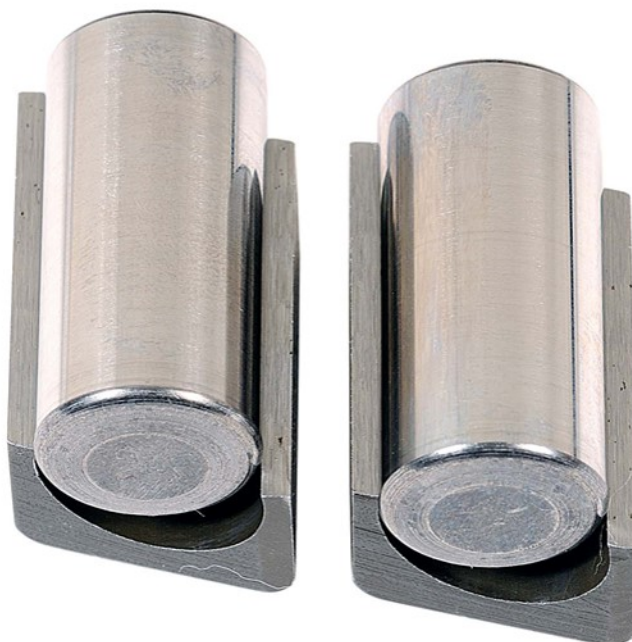
**Figure 29. Pump SN:17102938 Rollers and Shoe before Testing with 20/80 DSH8/JP-8 Fuel with 9-ppm CI/LI**

Figure 29 and Figure 30 is the Pre-Test and Post-Test conditions of fuel injection pump SN:17102938 roller shoe and roller conditions. Of note is the lack of a wear scar at the roller shoe leaf spring contact and the shiny, bright rollers shown in Figure 29. Figure 30 reveals light wear scars on the roller shoe from the leaf spring contact and burnishing of the rollers. The rollers tend to discolor when combination rolling-sliding action occurs as the rollers follow the injection cam profile. Figure 31 and Figure 32 show the moderate to heavy wear scar due to 500-Hours operation at the roller shoe plunger contact. The wear seen in Figure 32 is typical for a marginal lubricity fuel.

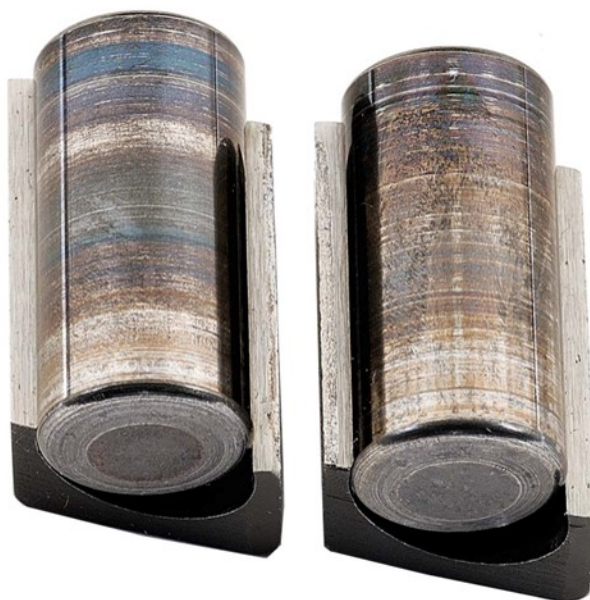
**Figure 30 Pump SN:17102938 Rollers and Shoe with 500-Hours Testing with 20/80 DSH8/JP-8 Fuel with 9-ppm CI/LI**

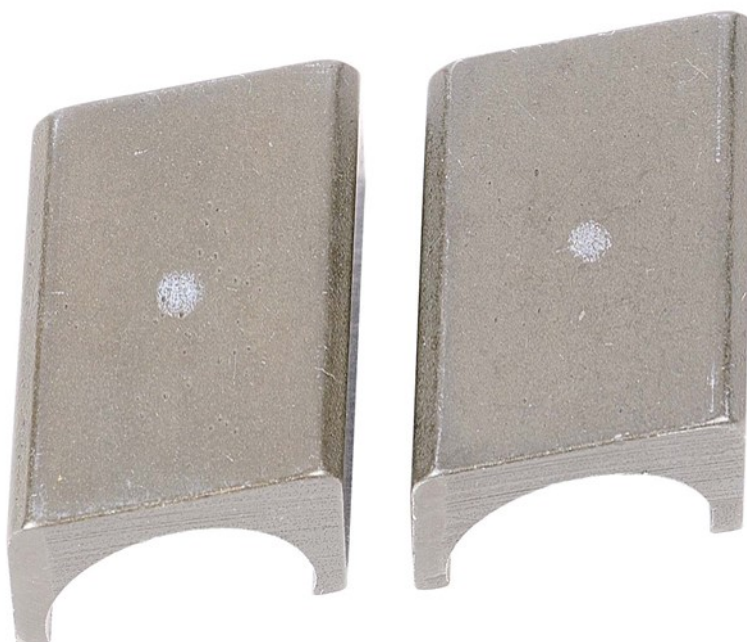
**Figure 31. Pump SN:17102938 Roller Shoe before Testing with 20/80 DSH8/JP-8 Fuel with 9-ppm CI/LI**

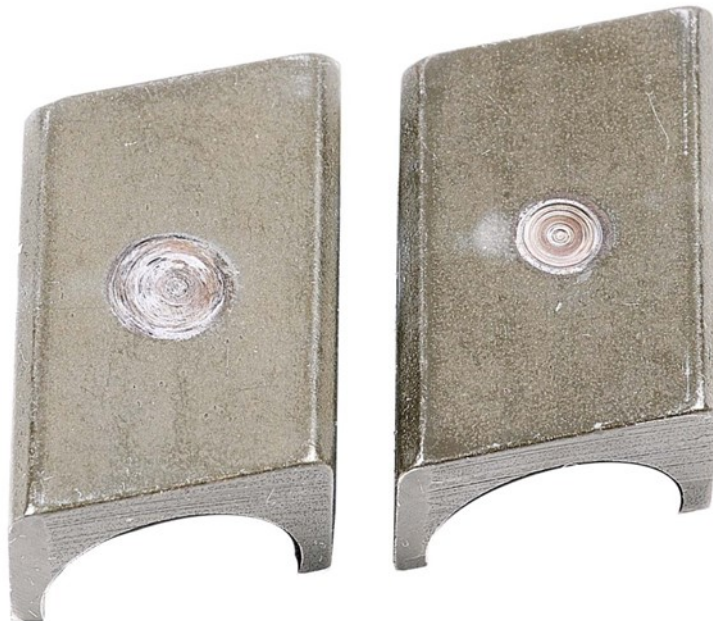
**Figure 32. Pump SN:17102938 Roller Shoe with 500-Hours Testing with 20/80 DSH8/JP-8 Fuel with 9-ppm CI/LI**

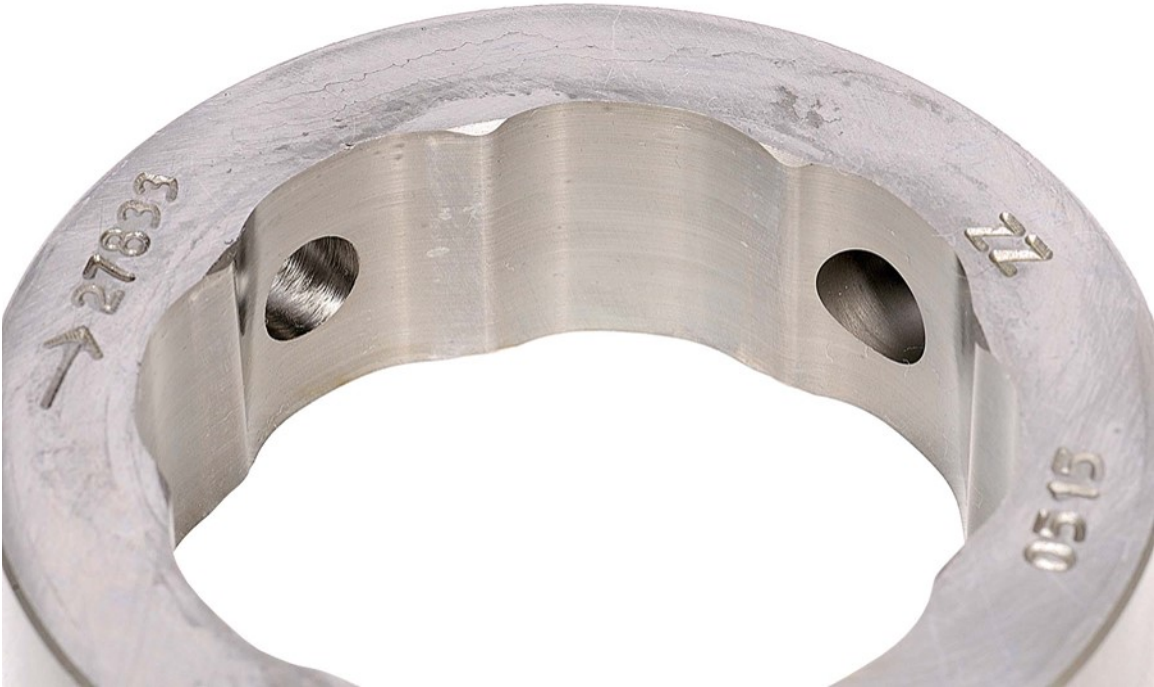
**Figure 33. Pump SN:17102938 Cam Ring before Testing with 20/80 DSH8/JP-8 Fuel with 9-ppm CI/LI**

The injection pump cam ring shown in Figure 33 and Figure 34 does reveal some polishing wear on the cam lobes from the rollers after 500-Hours operation with the DSH8/JP-8 fuel blend. The roller and cam distress with the DSH8/JP-8 blend with 9-ppm CI/LI is similar to what is typically seen with JP-8 with 22.5-ppm CI/LI after 500-Hours with 77 °C fuel inlet temperature.

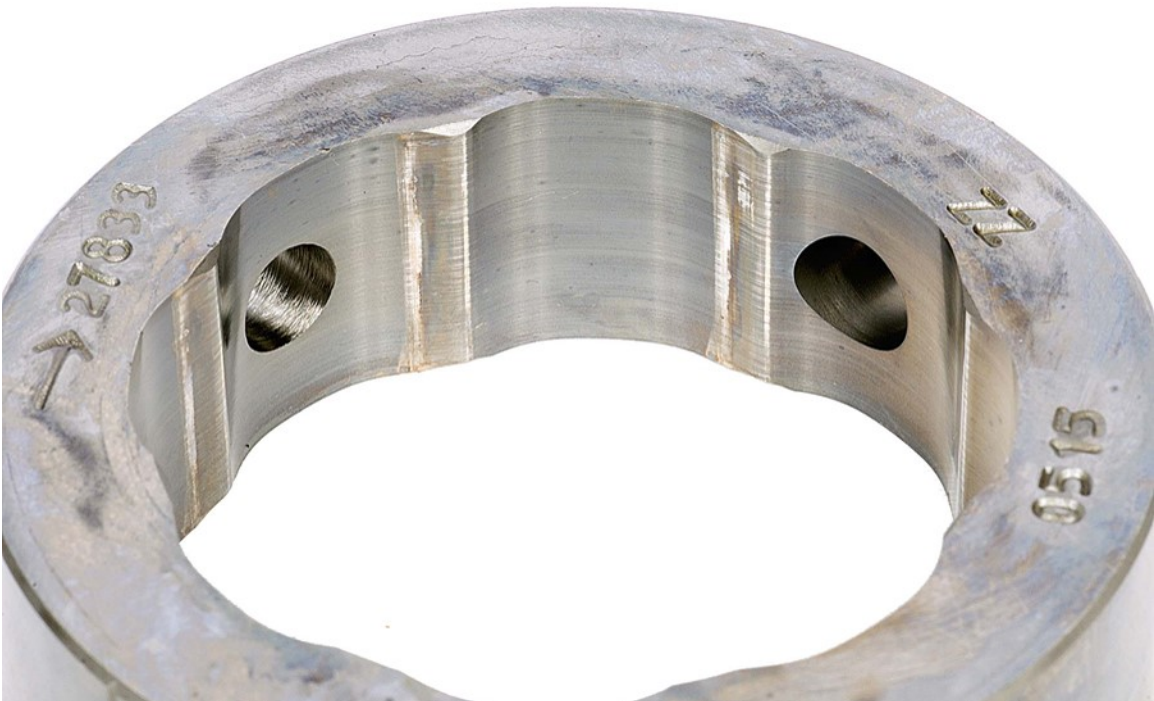
**Figure 34. Pump SN:17102938 Cam Ring with 500-Hours Testing with 20/80 DSH8/JP-8 Fuel with 9-ppm CI/LI**

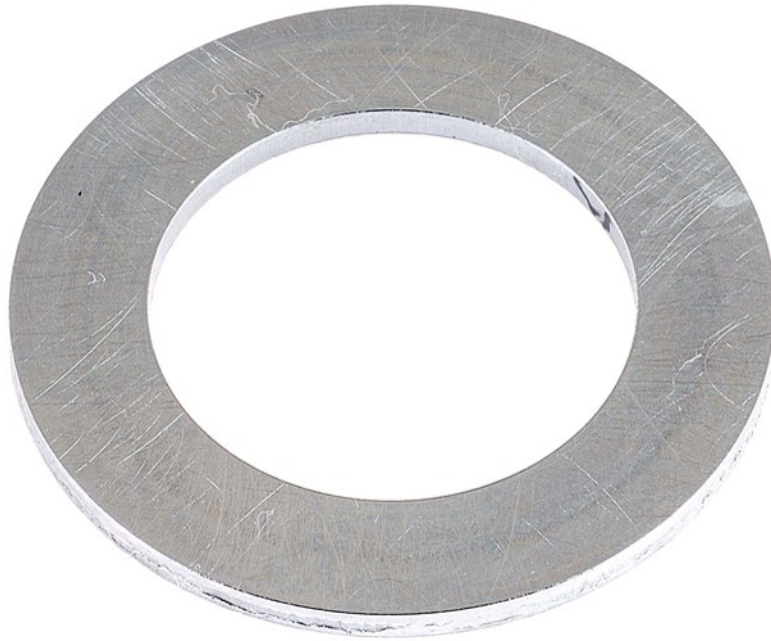
**Figure 35. Pump SN:17102938 Thrust Washer before Testing with 20/80 DSH8/JP-8 Fuel with 9-ppm CI/LI**

The governor thrust washer conditions before and after 500-Hours are seen in Figure 35 and Figure 36. The polishing wear seen on the thrust washer in Figure 36 appears typical for 500-hour operation with a nominal lubricity fuel. Fuel deposition, polishing and light scoring wear seen on the advance piston suggests the fuel pressure fluctuations in that area of the fuel injection pump housing. The metering valve regulates the pressure to the rotor fill ports. The pressure is regulated by the action of the helix changing the outlet area of an orifice. Due to WOT operation a lightly polished area shows at one location on the helix. The light wear on these components is normal

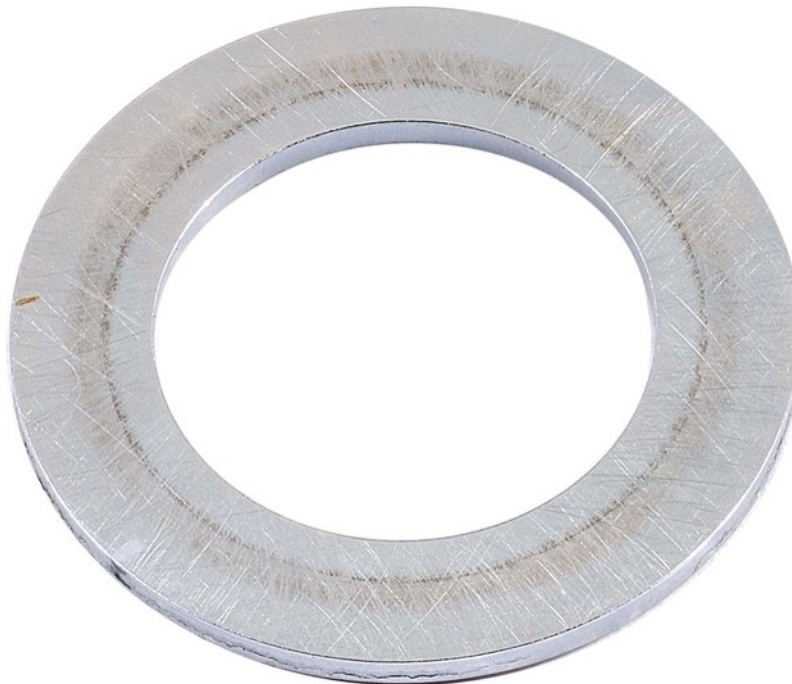
**Figure 36. Pump SN:17102938 Thrust Washer with 500-Hours Testing with 20/80 DSH8/JP-8 Fuel with 9-ppm CI/LI**

considering the 500-hour duration of testing. The advance piston wear and the metering valve polishing may have affected the governor cut-off operation.

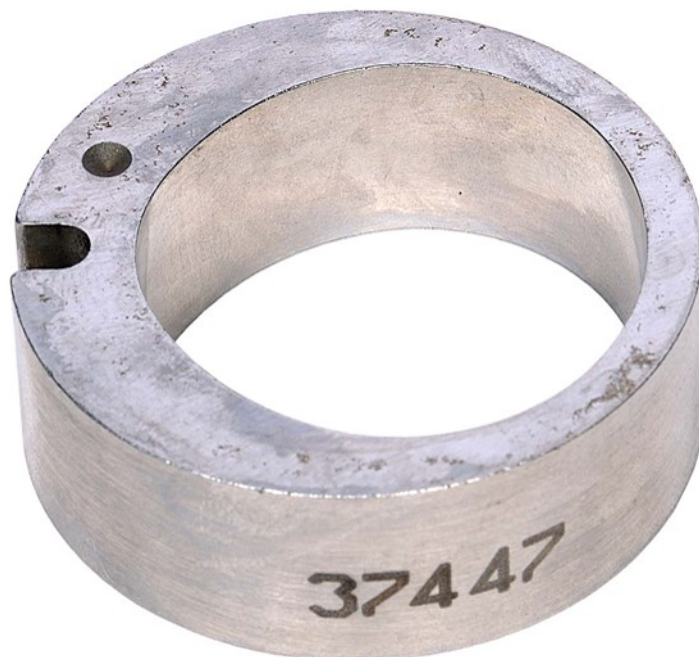
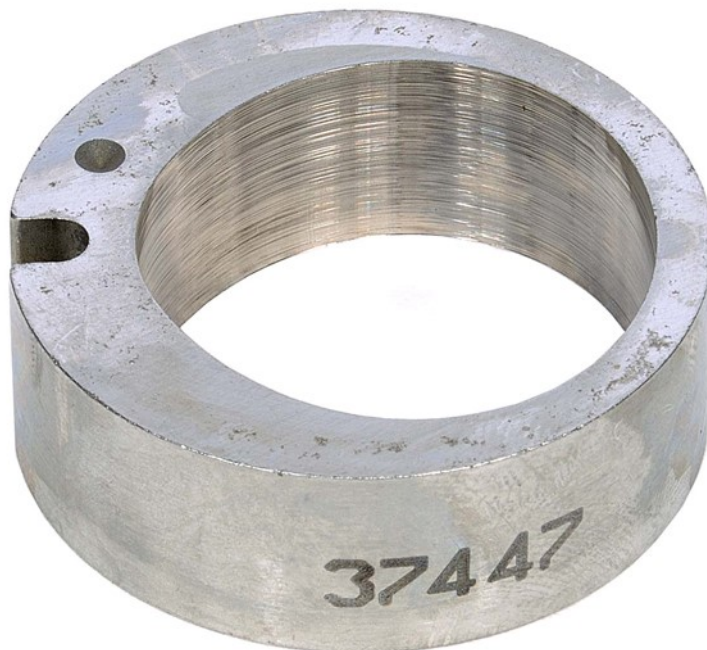
**Figure 37. Pump SN:17102938 Transfer Pump Liner before Testing with 20/80 DSH8/JP-8 Fuel with 9-ppm CI/LI**

**Figure 38. Pump SN:17102938 Transfer Pump Liner with 500-Hours Testing with 20/80 DSH8/JP-8 Fuel with 9-ppm CI/LI**

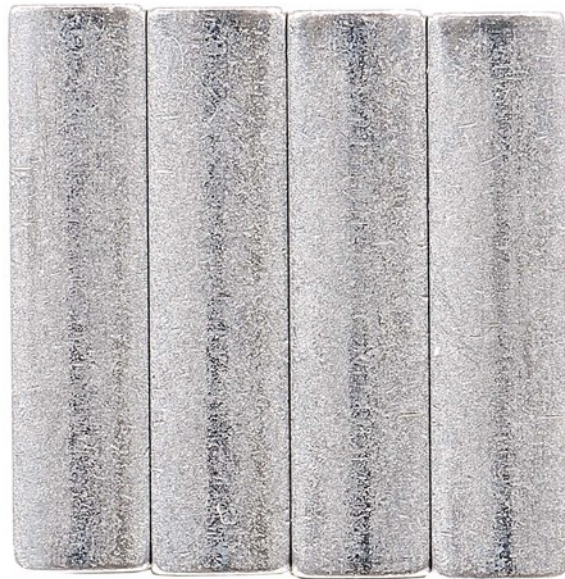
**Figure 39. Pump SN:17102938 Transfer Pump Blade Edges before Testing with 20/80 DSH8/JP-8 Fuel with 9-ppm CI/LI**

Figure 37 through Figure 42 illustrate the level of wear seen in the transfer pump section of fuel injection pump SN:17102938. Figure 37 shows the surface condition of the transfer pump liner prior to testing and Figure 38 shows the surface with 95% circumferential scoring after 500-Hours of operation on the DSH8/JP-8 fuel with 9-ppm CI/LI. Also illustrative of the transfer pump section wear are the transfer pump blade conditions shown in Figure 39 through Figure 42. The edge wear shown in Figure 39 and Figure 40 corresponds to the surface on the transfer pump blades that contact the transfer pump liner and are typical for 500-Hours operation with a marginal lubricity fuel. The side polishing shown in Figure 41 and Figure 42 reflect wear from the transfer pump blade slots on the injection pump rotor. The wear seen on the transfer pump components of pump SN:17102938 are slightly more severe than an elevated temperature JP-8 test with 25-ppm CI/LI treatment. The transfer pump component conditions suggest the test fuel has marginal fuel lubricity at elevated temperature.

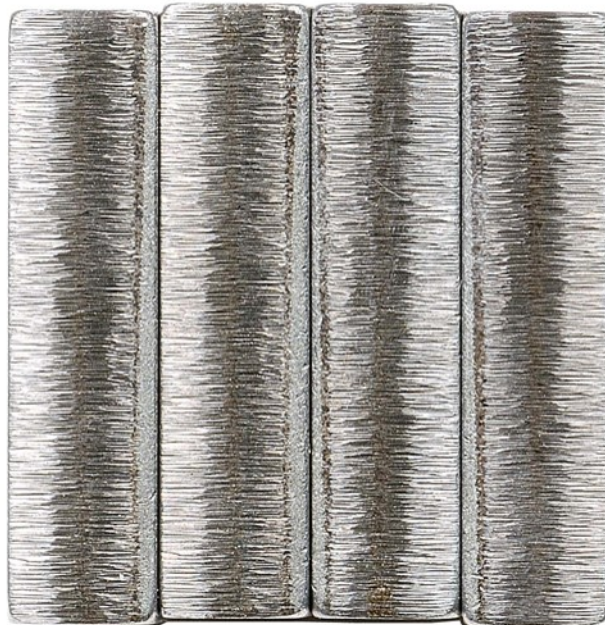
**Figure 40. Pump SN:17102938 Transfer Pump Blade Edges with 500-Hours Testing with 20/80 DSH8/JP-8 Fuel with 9-ppm CI/LI**

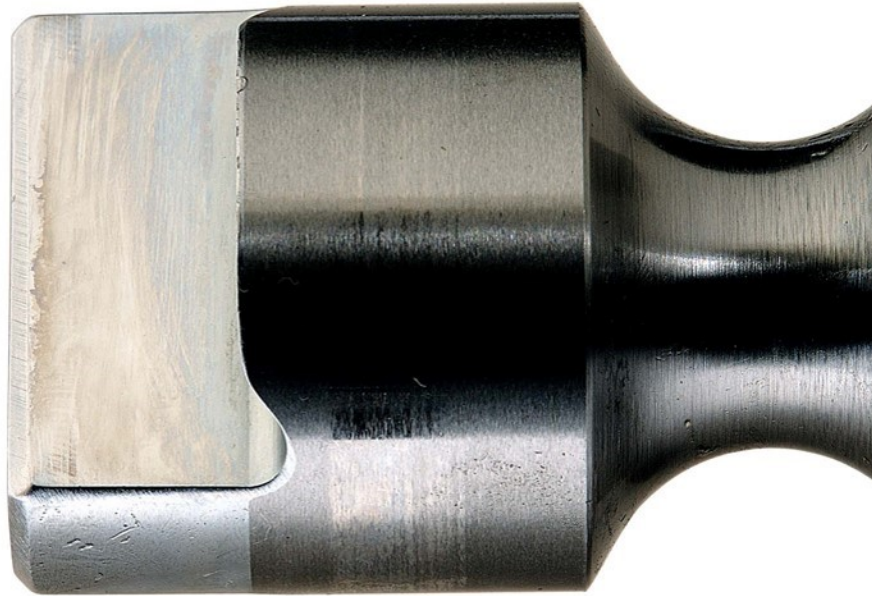
**Figure 43. Pump SN:17102938 Driveshaft Drive Tang before Testing with 20/80 DSH8/JP-8 Fuel with 9-ppm CI/LI**

Figure 43 and Figure 44 show the condition of the injection pump drive shaft drive tang that transmits torque to the hydraulic section of the pump from the engine. Figure 44 reveals a minimal wear scar that indicates backlash and timing were not altered with the DSH8/JP-8 fuel with 9-ppm CI/LI after 500-Hours. For both pumps that utilized the DSH8/JP-8 with 9-ppm CI/LI fuel, the worn components that impacted the injection pump performance variation were the roller and cam contact, and the transfer pump wear. Both pumps exhibited stable performance after 500-Hours at elevated temperature with the 20/80 DSH8/JP-8 fuel with 9-ppm CI/LI. Pump performance degradation at 500-Hours was more severe than seen with a JP-8 with 22.5-ppm CI/LI at elevated temperature.

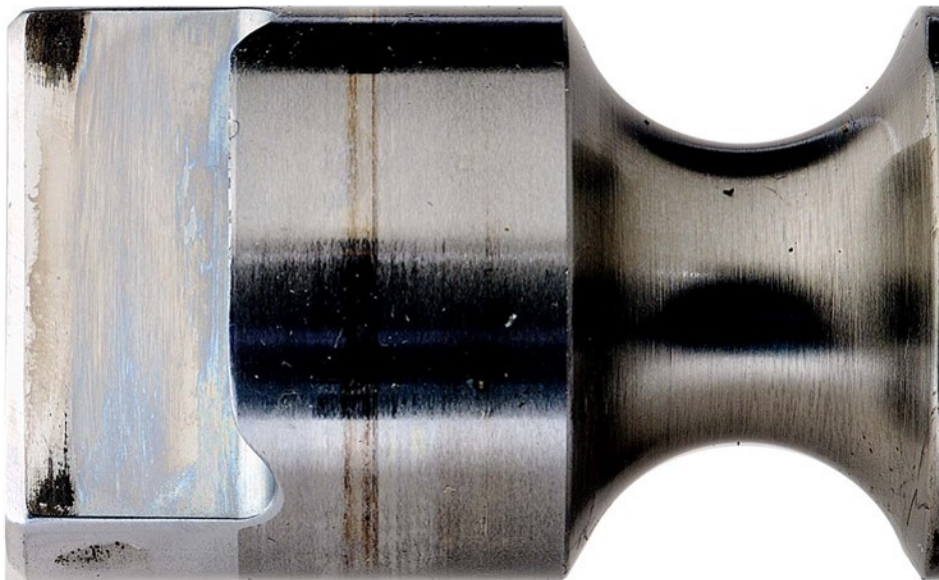
**Figure 44. Pump SN:17102938 Driveshaft Drive Tang with 500-Hours Testing with 20/80 DSH8/JP-8 Fuel with 9-ppm CI/LI**

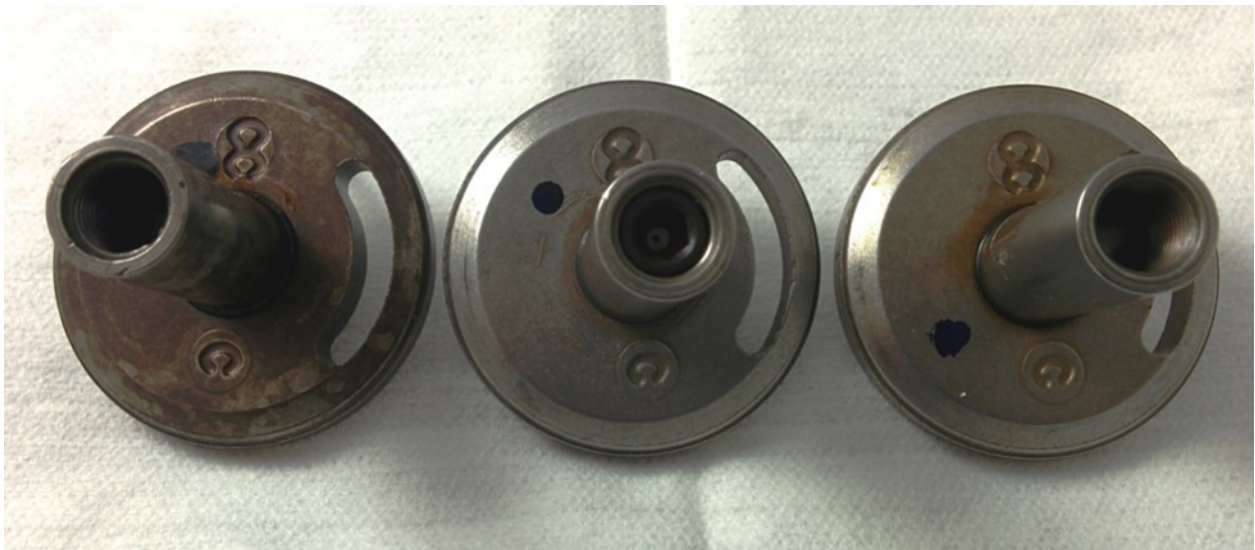
During the component inspections and noted in Table 11 and Table 12, was evidence of brown fuel deposits on some of the components, particularly on the transfer pump regulator. Inspection of the transfer pump endplate and pressure regulator revealed a particularly heavy and sticky deposit for one of the test pumps. Figure 45 shows three fuel injection pump endplates, the plates at each end are the DSH8 pump test plates, and the plate in the middle is from a 210-hour ATJ engine test. The heavy brown deposit on the left most plate was sticky and tacky. Figure 46 shows the liner side of the transfer pump regulator plates with fuel deposition evident. Fuel deposition was heavier and stickier for the plate from pump SN:17102938.

**Figure 45. Transfer Pump Endplate Deposition: DSH8 SN:17102938 Endplate Left, ATJ Engine Test Endplate Middle, and DSH8 SN:17102937 Endplate Right**
